## Service Bulletin SB1001

**Trouble:** Water pump is not operating when the PUMP switch is ON, no green LED is ON or BLINKING on IRVWPC module.

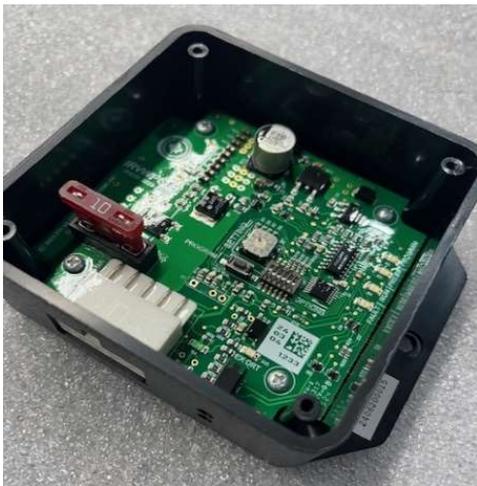
**Possible Cause:** The IRVWPC control module contains a serviceable standard AUTOMOTIVE ATOF 10A fuse. This fuse protects the module and the power going to the RV water pump. Below freezing temperatures can cause ice/slush within the water pump putting the pump motor into an overload condition drawing excessive current. This current will either blow the pump fuse in the RVs power distribution center or the fuse within the module.

IRVWPC module with the cover removed showing the 10A fuse.

**Solution:** First inspect the fuse in the RVs distribution center, if this fuse is not blown, then inspect the fuse within the module itself. The module can be easily removed by unplugging the locking connector on the module wiring harness and removing the two mounting screws. Access to the fuse is by removing the 4 Phillips head screws on the module cover and lifting off the cover plate. The fuse is installed in a standard push in fuse holder socket. Remove the fuse and inspect for an open circuit. If the fuse is found to be open circuit, replace the fuse with the same 10A rating. Install the cover screws and verify pump operation.
